PFOW Enabling Actions Project: Sub-sea Cable Lifecycle Study

February 2015

In March 2014, EMEC received funding from The Crown Estate to collate and review information about the integrity of sub-sea cables installed at the EMEC wave and tidal test sites to help inform on their performance in high energy environments. EMEC sub-contracted submarine cable specialists Engineering Technology Applications Ltd (ETA) to carry out this review.

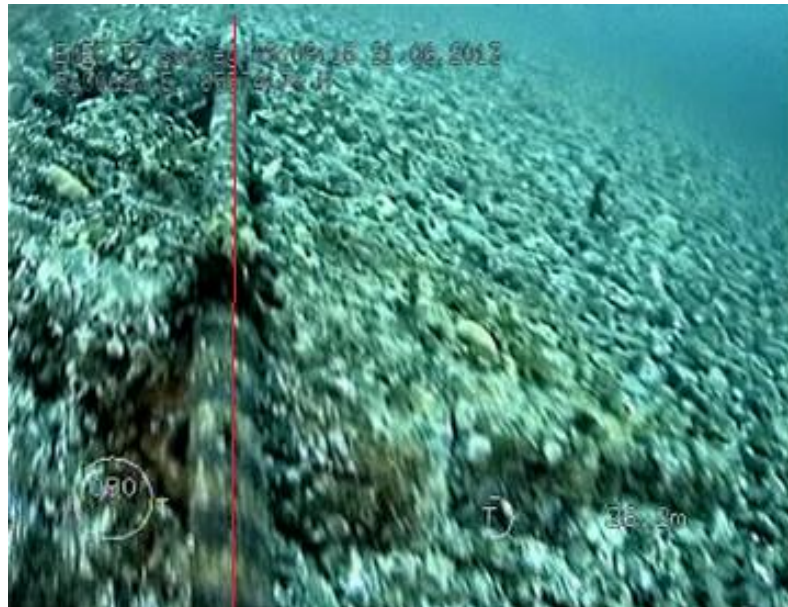
Figure 8: ROV still showing typical abrasion caused by cable strumming

with these areas compared to the cable condition visible from the ROV surveys. Figure 8 below shows an example of abrasion to sub-sea cable serving due to strumming.

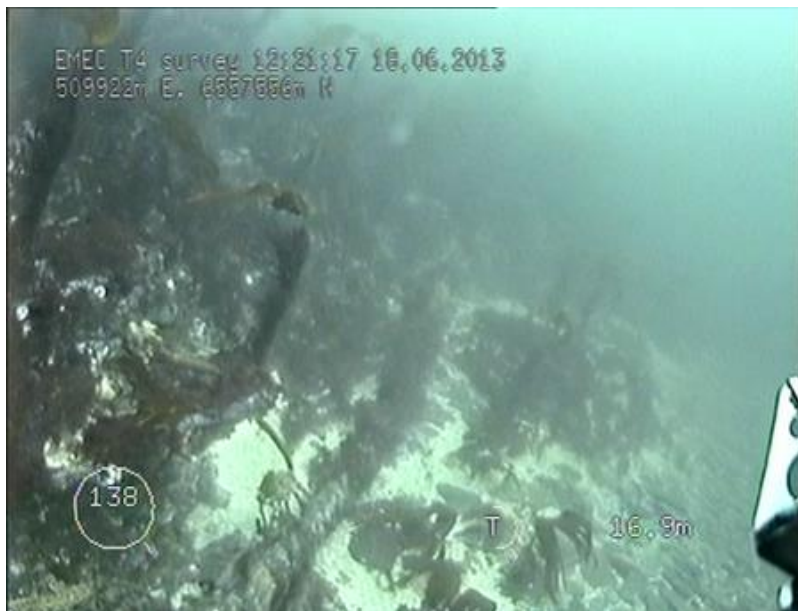
Figure 9: Possible wear caused by cable movement

Due to the difficulties associated with assessing the causes of abrasive wear, further detailed analysis from the data available at present provides little additional detail (it is difficult to separate possible abrasion due to movement from potential minor strumming and discolouration phenomena). Also, it is possible that the cables could have received considerable serving wear during installation, recovery, and relocation works (reports from installation and remedial work on T4 note this serving damage as having occurred). Serving wear alone therefore is not necessarily indicative of cable instability. An example of wear possibly caused by cable instability is shown in Figure 9 below.

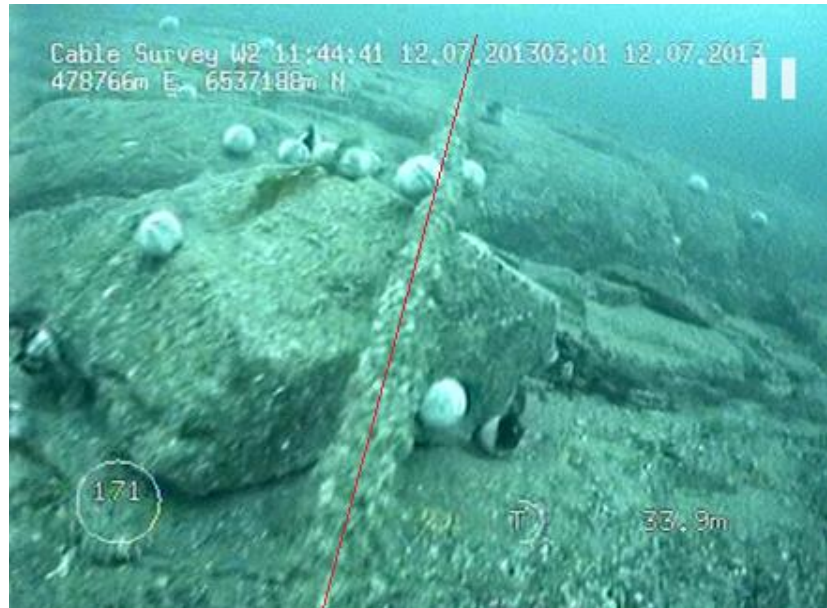
While the cables appear strained around the contact points, no significant wear was observed in the ROV footage reviewed. This suggests that rock contacts are not a significant threat to the external components of a cable. However, where a cable is under significant stress it could be considered likely that internal damage may occur. Such internal damage cannot be assessed from current information, but given the frequency of rock contacts identified at the test sites (with contacts occurring on all cables reviewed, and similar stresses being observed at freespan touch down points) this is an important area which would benefit from further studies.

Figure 10: Rock contact with cable W2

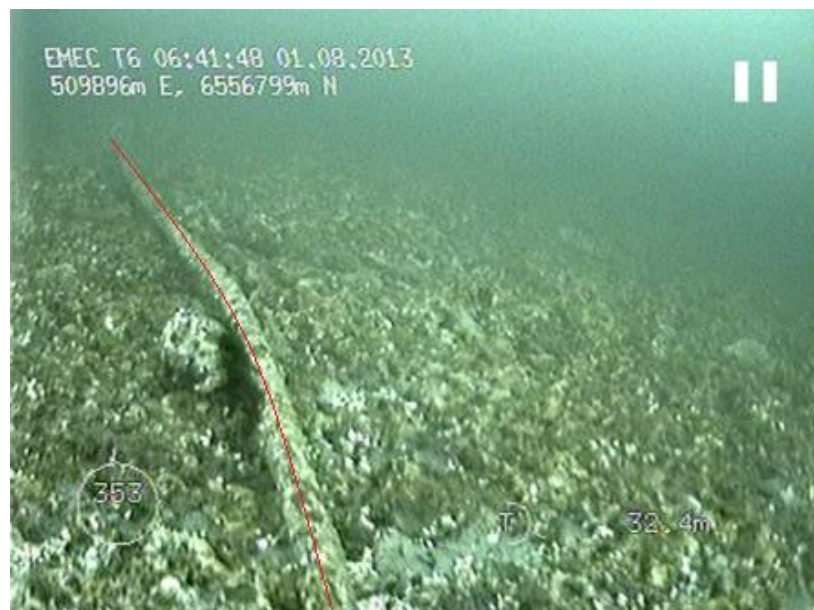
Figure 11: Rock contact with cable T6

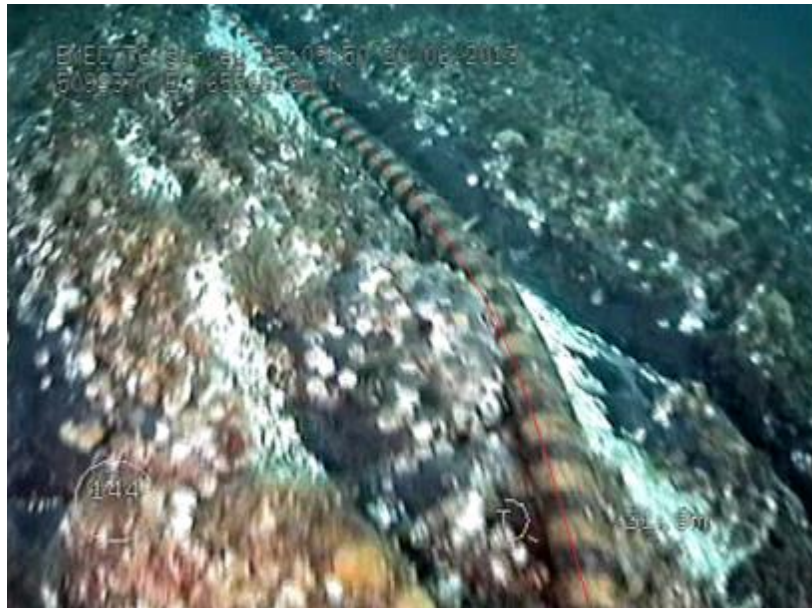
Figure 12: Rock contact with cable T7

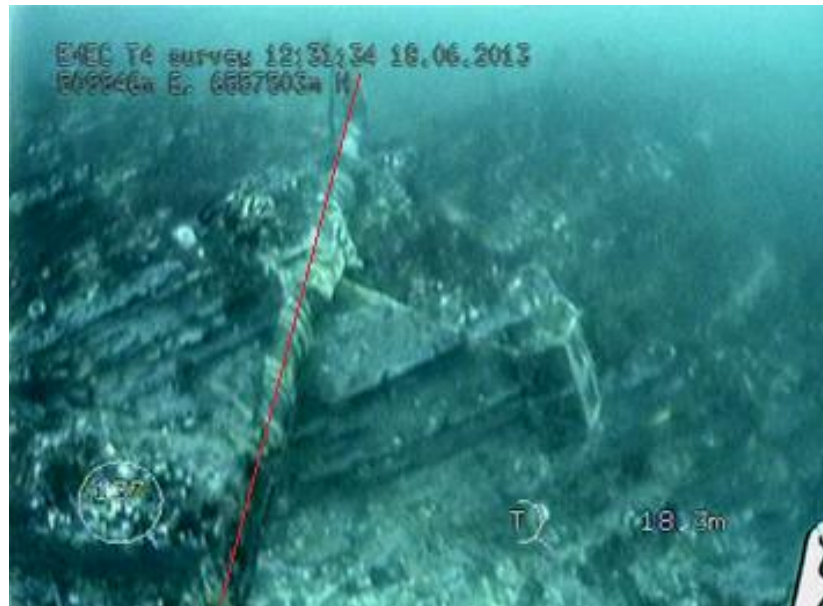
Figure 13: Interaction of fishing creel with EMEC cable T4

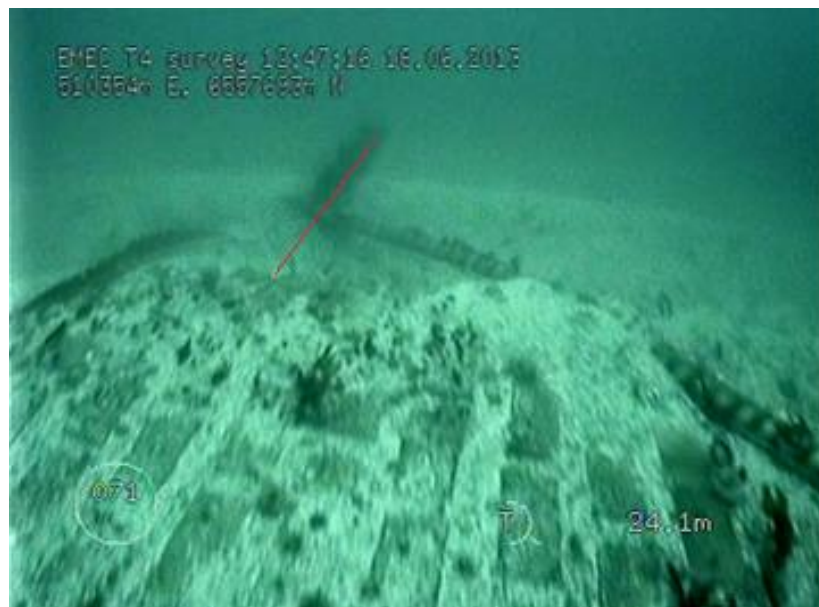
A further example of anthropogenic interaction can be seen where cable T6 crosses T4 (see Figure 14 below). In this example the mattress has been incorrectly positioned and T6 is in contact with T4 shown above. While this contact is undesirable, there is no observable evidence of any damage to either cable.

Figure 14: Mattress crossing T4 with T6 (cables in contact)

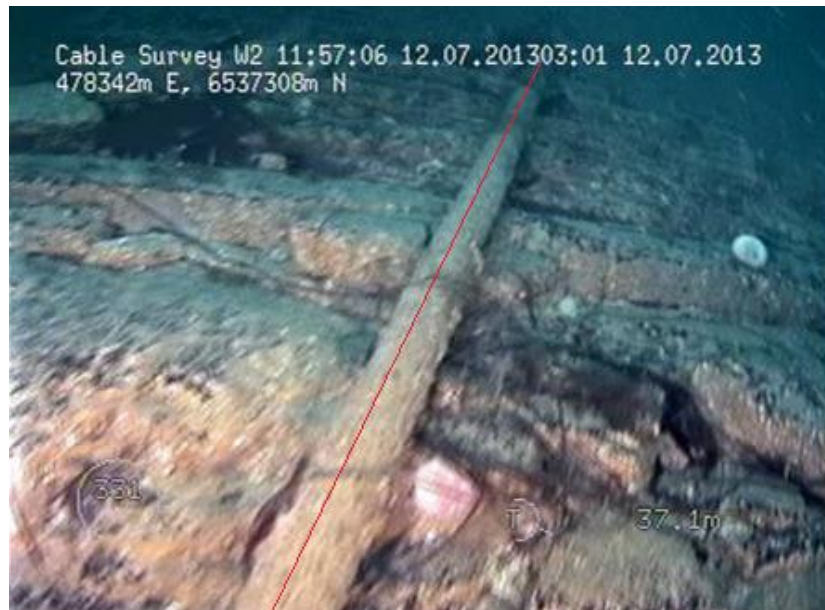
At the EMEC wave energy test site, the study identified several instances of anthropogenic interaction with the cables reviewed. These interactions involved fishing equipment and equipment related to the cable installation operations. Figure 15 below shows a wire-like material, possibly from installation, wrapped around cable W2. This has not caused any damage to the cable.

Figure 15: Wire-like material around cable W2

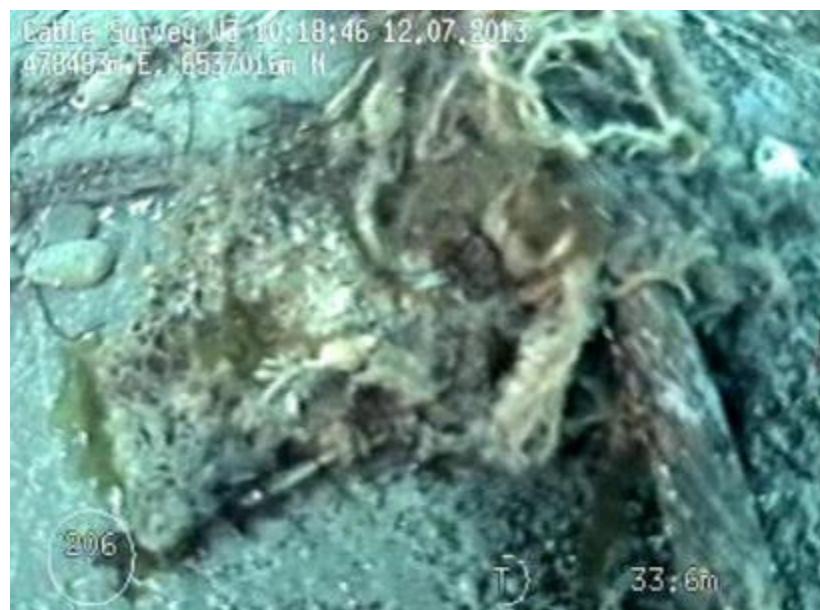
Figure 16 below shows a wrecked fishing creel next to cable W3. Significant serving wear is visible and, although inconclusive, it seems likely that this was caused by interaction with the creel.

Figure 16: Wrecked fishing creel interacting with cable W3
