# FoDTEC final summary report

Author: Tim Warren  
Date: 07/05/2020  
Reference: FT-008  
Version: A

After the removal of the TGL tidal turbine foundation that was installed at EMEC's Fall of Warness tidal test site, the FoDTEC project has completed activities to assess biofouling, corrosion, metallurgical defects and electrical connector longevity. Work has been completed by the following partners in the project:

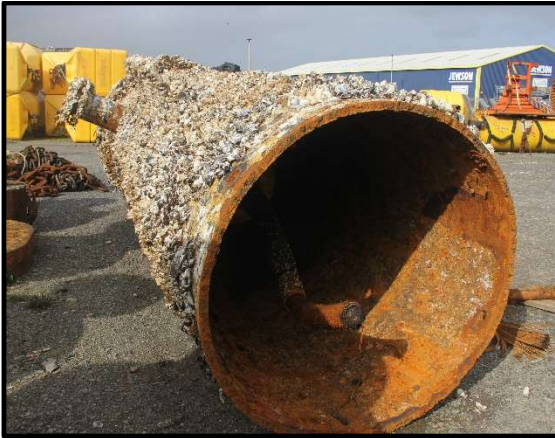
Tower top survey: this structure was almost entirely covered in biofouling organisms creating a complex matrix extending typically 8-10cm but in places to over 12 cm in thickness (Figure 5). The dominant species were *Chirona hameri*, *Mytilus edulis*, and a wide variety of sponges, especially underneath features. Significant fouling was observed of saddle oysters, a turf of hydroids, and the barnacle *Balanus balanus*. Biofouling of structures placed in the marine environment will undergo a series of successional changes, depending upon the season of deployment. Pioneering macrofouling is often associated with colonial hydroids. After prolonged deployment, larger and more slow-growth species may dominate fouling. Studies of the fouling assemblages on the TGL tripod reported here can be considered as indicative of 'end-stage' or 'climax' biofouling communities on steel in these habitats. Once these stages have been reached, the assemblages observed here would not be expected to change much over time, except for localised areas of disturbance. Reports from the oil and gas sector have identified similar fouling assemblages on long-term deployed infrastructure in the North Sea (Forteath *et al.*, 1982). Patches of thicker fouling versus exposed substrate indicate that some level of disturbance can and does occur, perhaps as the consequence of large sediment impact.

Figure 5 - The vertical subunit of the tripod surveyed on 15 September 2019. Note the thick encrustation of barnacles and mussels

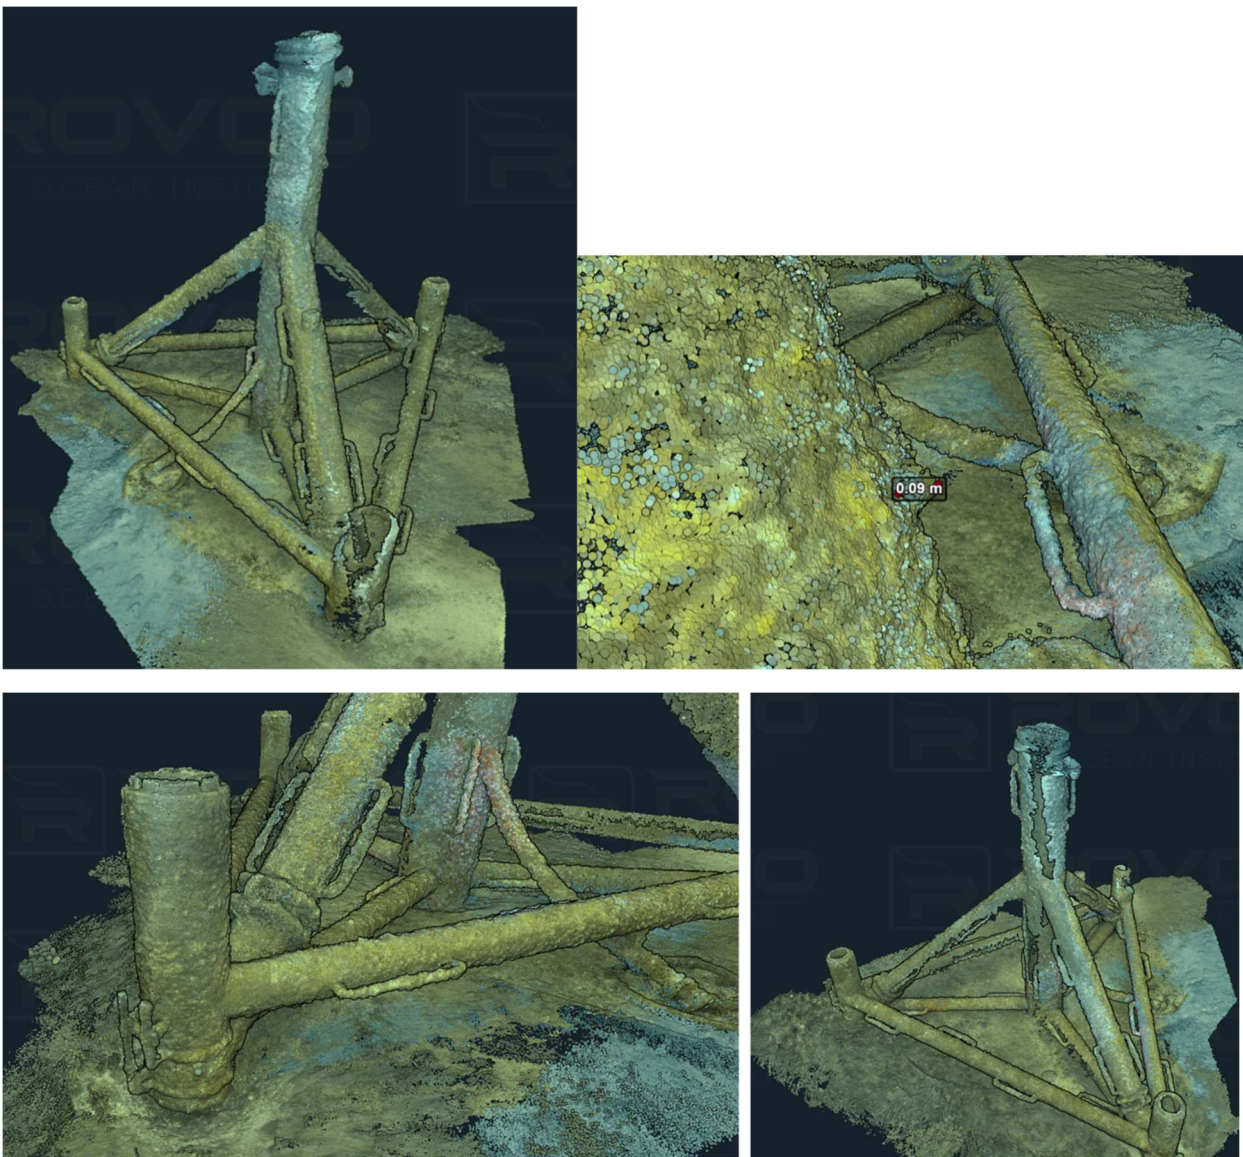
Figure 7 - 3D scanned point cloud data of underwater tripod, showing overview, a measured biofouling thickness and details of key features.

- The 3D point cloud images provide excellent overview of the tripod, and it is clear that this technique can provide invaluable data for subsequent marine operations.
- Some point cloud data is missing, in particular on the underside and “inside” surfaces of the tripod members. This is due to restricted access of the ROV, as it is unable to fly under some members to view the underside.
- Analysis to determine the effects of tidal direction have not highlighted any particular results. This implies that flow speed in tidal sites is not too fast to prevent growth, nor is there any preference of biofouling to grow in higher or lower flow speed regions. This is corroborated by the biofouling survey and visual inspections
- Assessment to determine biofouling thickness has determined a large range of thicknesses. This is not particularly dependent upon flow direction.

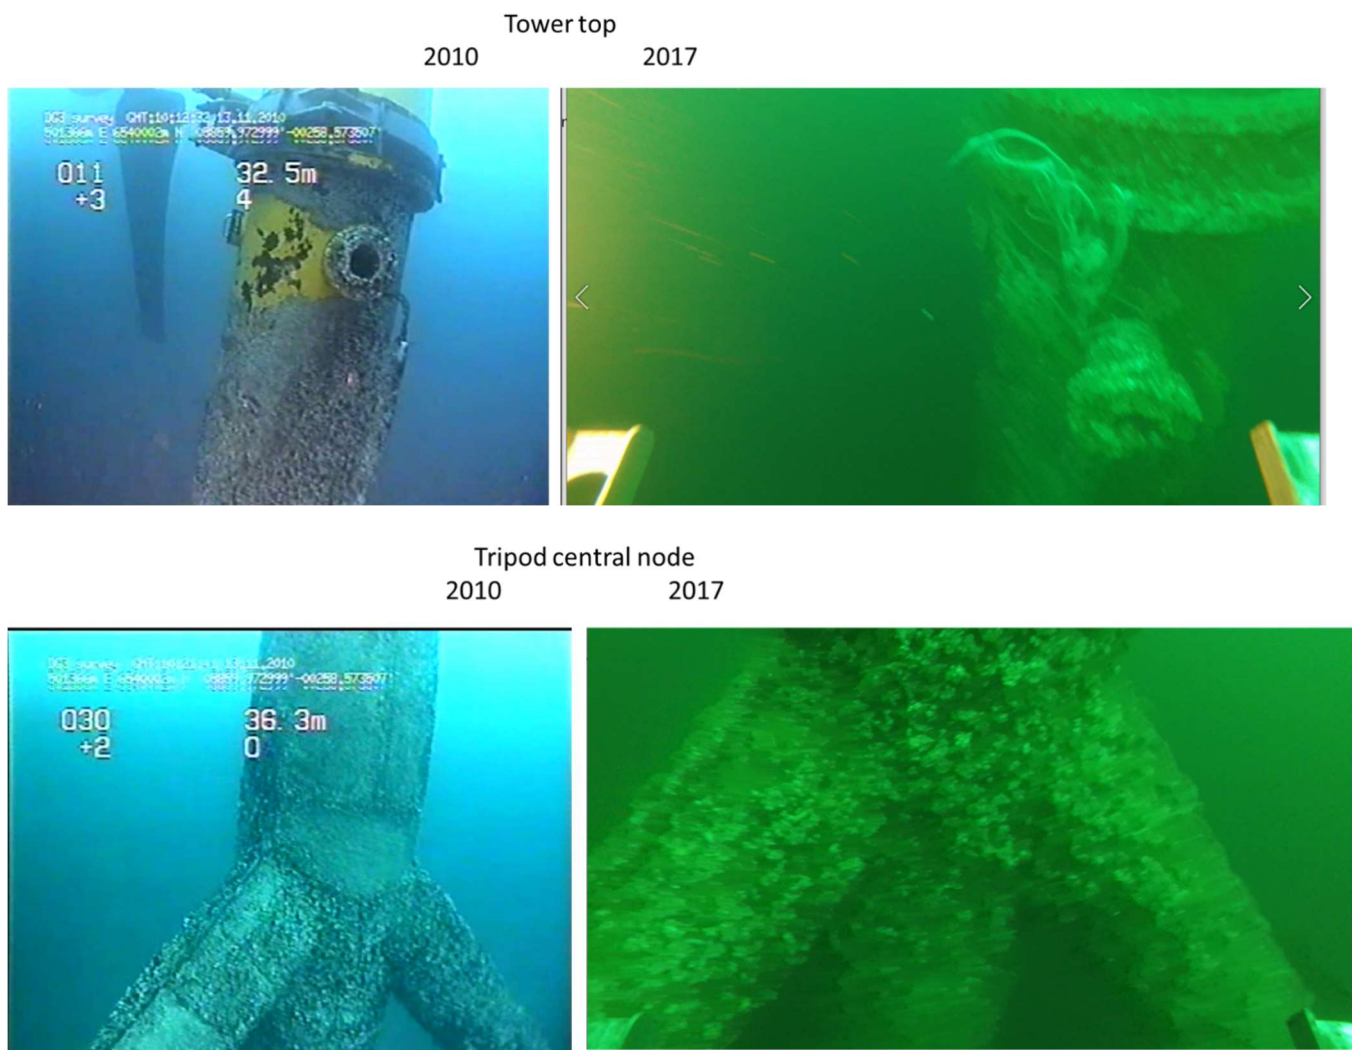
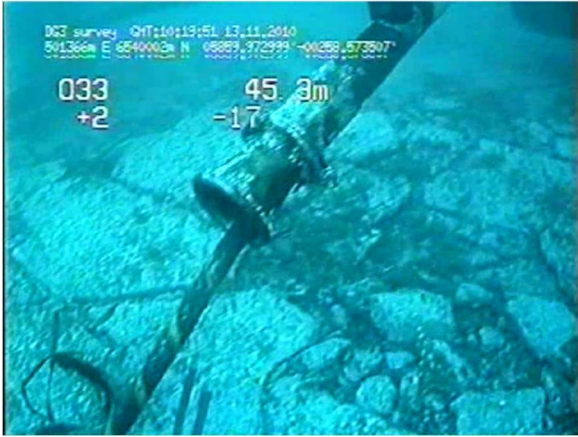
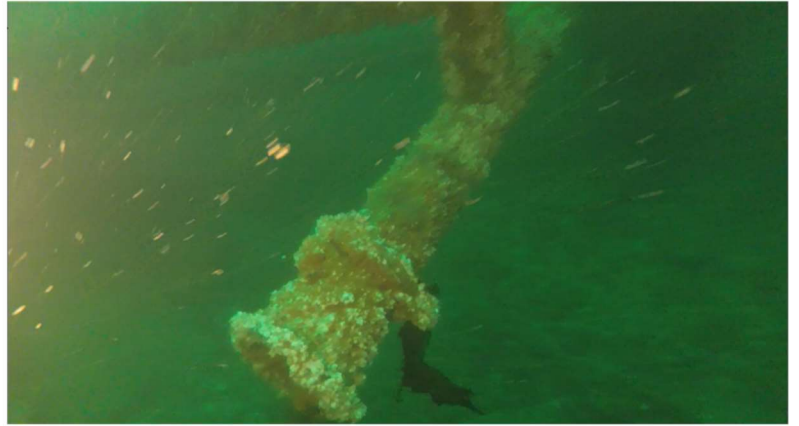
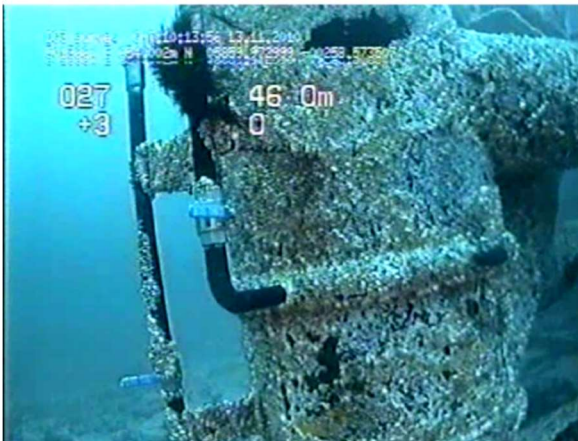
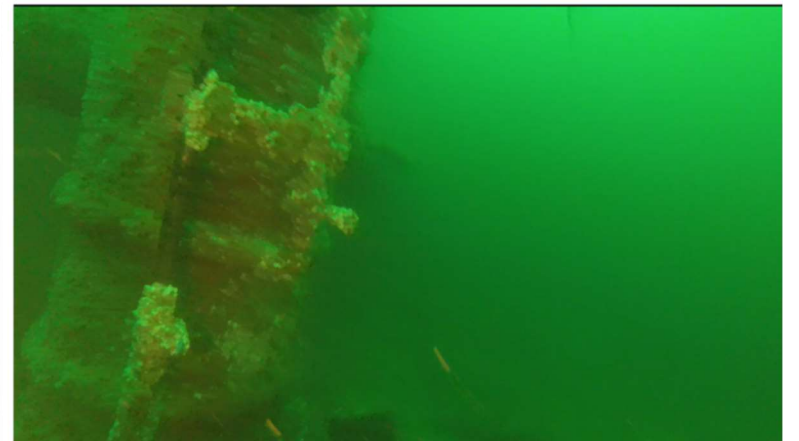
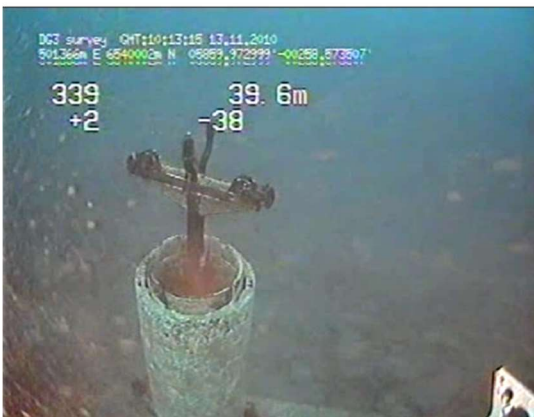
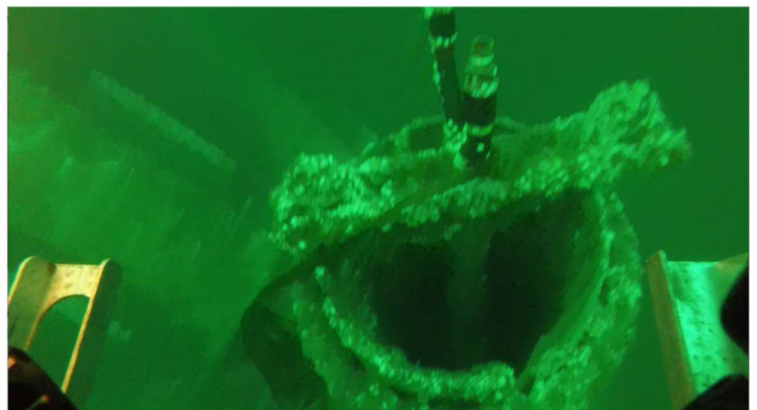
Figure 8 - ROV footage comparisons between 2010 and 2017

J-tube with cable exit  
2010                      2017

Tripod leg with grout lines  
2010                      2017

Tripod leg with stinger  
2010                      2017

Specific conclusions from the ROV footage are difficult to draw, but it is clear that the biofouling has increased significantly over the time period. It is not possible to infer conclusions about directionality of the tidal flow and the effect on bio-fouling, but it is clear that biofouling is less dense where:

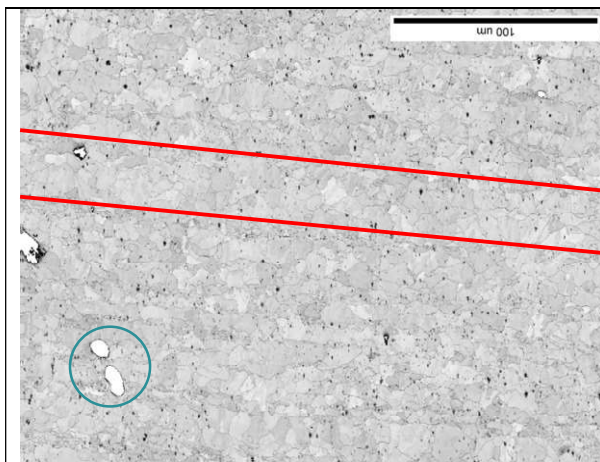
This sample showed a ferritic structure, determined using the indexing of the diffraction patterns obtained by EBSD, with randomly oriented (Figure 14) equiaxed grains of 10-20  $\mu\text{m}$  size. Bands (highlighted in red in Figure 11) derived from the hot rolling are visible in the material without any deformation of the alignment. Furthermore, the random orientation observed (Figure 11 and Figure 14) indicates that heat treatment was performed after rolling to minimise the rolling effect and allow grain relaxation. Strain can be seen as internal misorientation ion the grains, but no strain was visible within the grains, any misorientation detected was due to sample preparation This can be ascertained looking at the variation of orientation (misorientation) within the grains and observing if this variation continues in the adjacent grain or not. If the misorientation can be seen in 2 or more adjacent grains than the variation is due to sample preparation, if it is confined within one grain then it is due to strain. Some porosity is visible in the sample (left hand side of Figure 11, white ellipsoidal points highlighted with blue circle), however they do not show any link with the exposed surface (i.e. they are not linked to pitting) and they do not show any deformation

Figure 11 Image Quality map showing the banding phenomenon (highlighted in red) and some porosity (white ellipses in the left-hand corner)

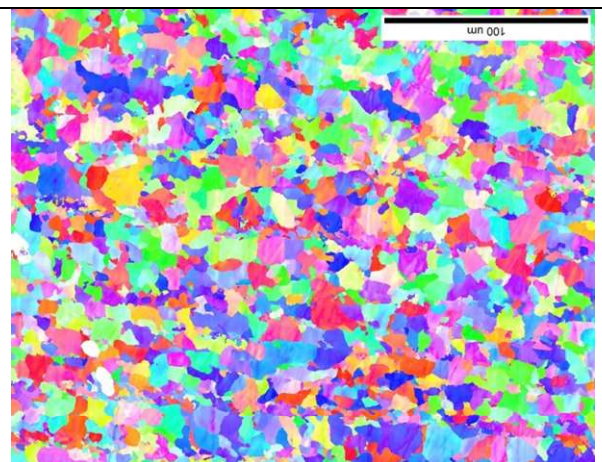
Figure 12 Inverse Pole Figure map showing the random orientation of the grains and the banding of smaller grains (perlites)

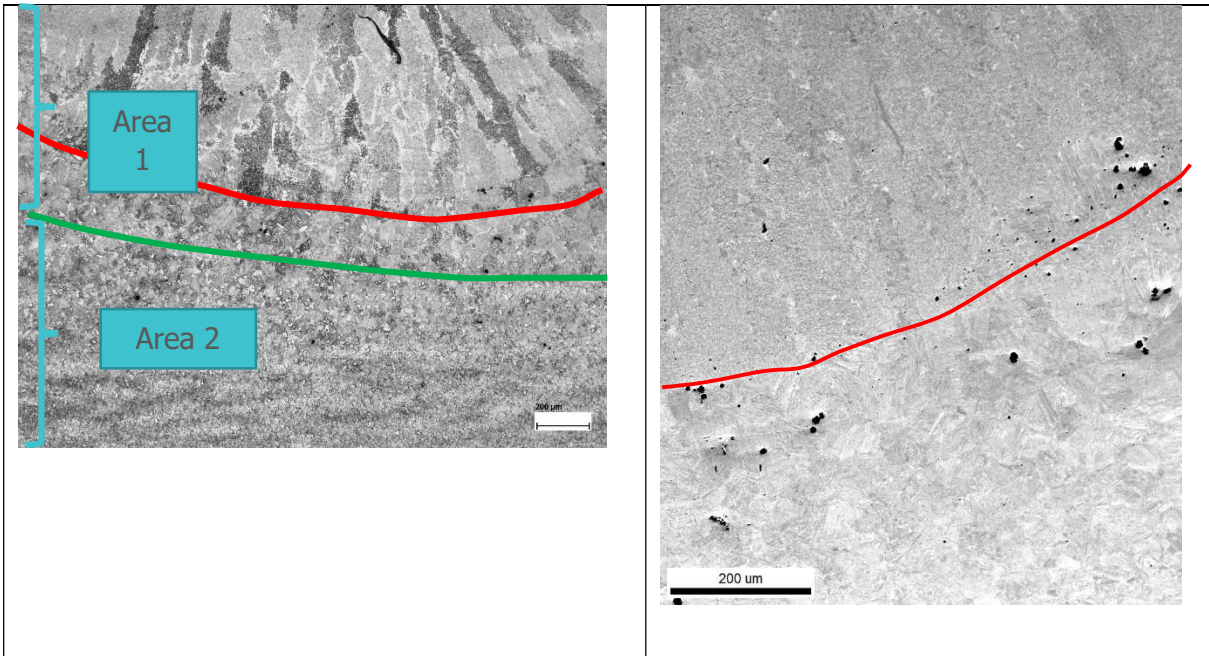
Area 1 (Figure 18) The optical microscopy observation shows a variation in the texture of the sample (elongated grains above the red line in Figure 19, Widmannstatten microstructure between the red and the green line and equiaxed grains below the green line). On the top elongated grains are visible, then a Widmannstatten microstructure can be observed with an area containing equiaxed grains beneath. Closer observation using electron microscopy on the top section (Figure 20, Figure 22 and Figure 24) indicated that the grain start recrystallising as elongated dendrites growing perpendicular to the top surface and are then quenched during the welding, and rapidly cooled provoking a large outer grain while on the inside very small single grains were formed (Figure 21). The specific orientation relationship between the finer grains in this top section is 47 degrees, which corresponds to the orientation relationship in the bottom section of this sample (below the red line) typical of body centre cubic ferritic iron under rapid conditions transforming the ferritic structure into a Widmannstatten one, generally present in welds and seams. This microstructure consists of intertwined lamellar grains, with a relationship similar to the one showed for twinings, deriving from the fast cooling of austenitic grains produced in the ferritic steel by heating above the stability temperature of ferrite (which happens during welding) . Porosity is also visible in this area indicating (1) a decrease in volume of the material, which corresponds with the description of the twinning formation creating the Widmannstatten microstructure, as described by Cox (1954), (2) gas formation during the welding process. An evaluation of the strains in these areas was performed (Figure 23, Figure 24). The Kernel maps are shown in red the areas with higher strains. Analysing the results it can be noted that areas of major strains are the "shells" of the elongated grains in the welding areas (Figure 24), containing the finer grains deriving from the quenching process after welding. In detail (Figure 23) further strain is visible in the Widmannstatten area just below the elongated dendrites (below the red line in Figure 19, Figure 20, Figure 22) , while the strain decreases in the Widmannstatten area further below. This location of the strain and the associated location of the

porosity seem to point towards a phenomenon linked to the welding process more than with the use which could be expected to occupy a larger portion of the sample and not been limited to the heat affected zone of the welding itself.

Figure 19 Optical microscope image of sample A3-1 showing the upper region of elongated grains towards the surface of the V shape area (Figure 17, Figure 18), above the red line. Between the red and the green line is the Widmannstatten area and below the green line the equiaxed ferritic/pearlitic zone.

The sample A3-1 shows a microstructure with evidence of overheating, as expected in a welding area, with a fine grained quenched top layer and a Widmannstatten area just below. The presence of porosity and the fact that the Widmannstatten microstructure is harder and more brittle, could have caused failure in the material and high strain concentration. However, fact that the porosity is not deformed seem to indicate that the microstructure is convincingly the result of the welding process more than the response of the stresses during use, and no fractures or fatigue corrosions were initiated in this areas.

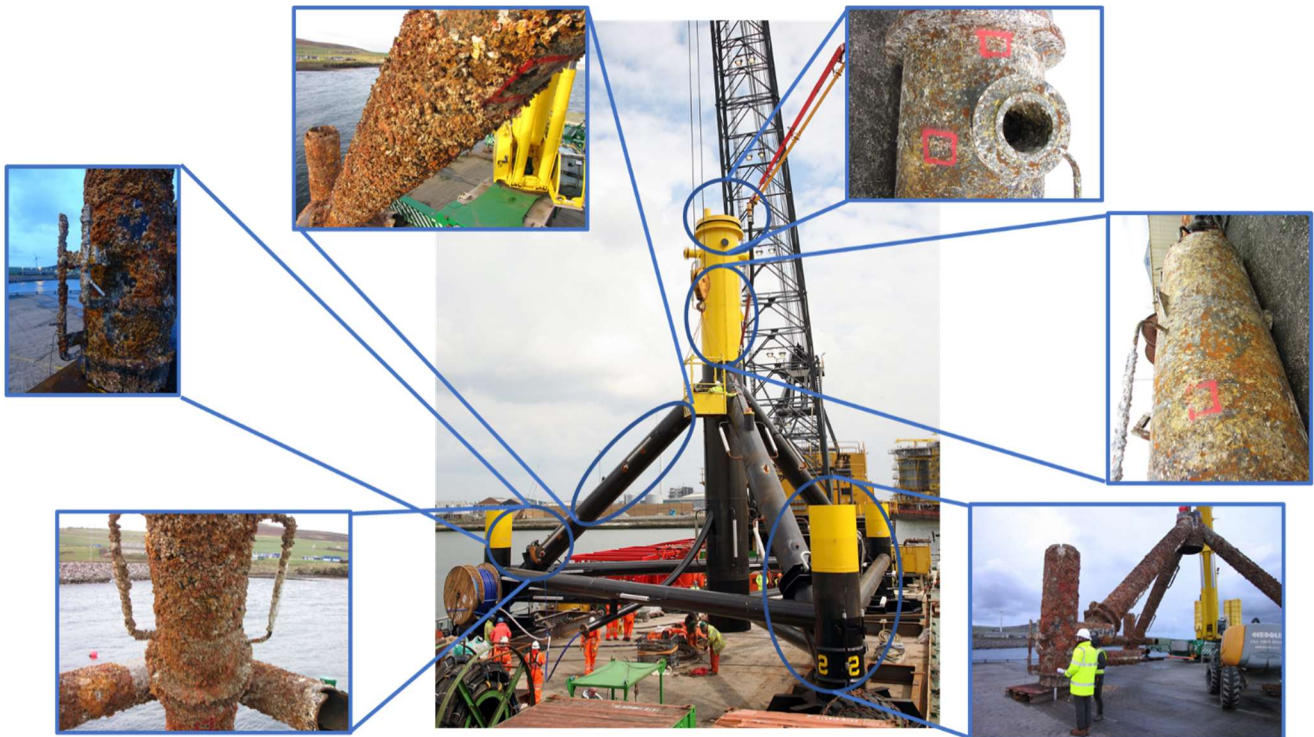
- Biofouling is extremely heavy in nearly all areas. Very few parts of original steelwork are visible. ICIT noted that biofouling is typical of end-stage' or 'climax' biofouling communities. Thicknesses up to 12cm are present.
- Overall, there does not appear to be a significant directionality effect due to the tidal flow. Growth is relatively even across all areas of the tripod. It has been noted that in sheltered areas there are some different species, most notably sponges

- The painted carbon steel surfaces seem to have survived reasonably well. Where biofouling has been scraped away, there is still significant evidence of the black paint. In general, the top section seems to have suffered worse, with random patches of rust covering approx. 25% of the surface area and this may well be due to the increased flow velocity higher from the seabed. Significant biofouling of the main tripod members makes a similar assessment difficult, but where biofouling has been removed the paint seems to be in-tact.

- There is very little evidence of any yellow topcoat paint left.
- The stainless 316L components, including M4-M10 fasteners, have survived well and little corrosion is visible. Some discolouration is present but overall. Fasteners have been unscrewed from their holes rather than needing to be cut off.

Figure 26 - Overview of tripod condition after 11 years

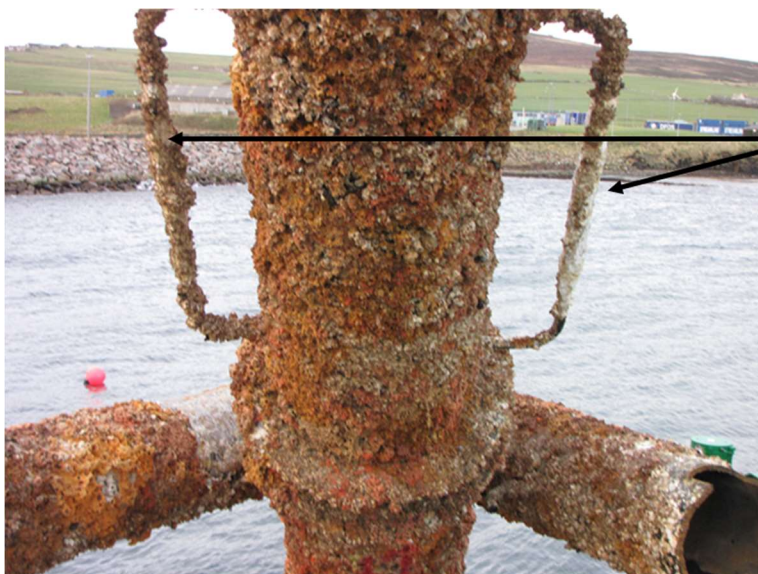
Photographs clearly show that the sponge species seem to be attracted to the anodes, as can be seen in Figure 28 below. It cannot be confirmed if this has a detrimental effect on the cathodic protection performance of the anodes, but may be something to investigate further.

Anodes with particular prevalence of sponges

Figure 28 - condition of anodes after 11 years

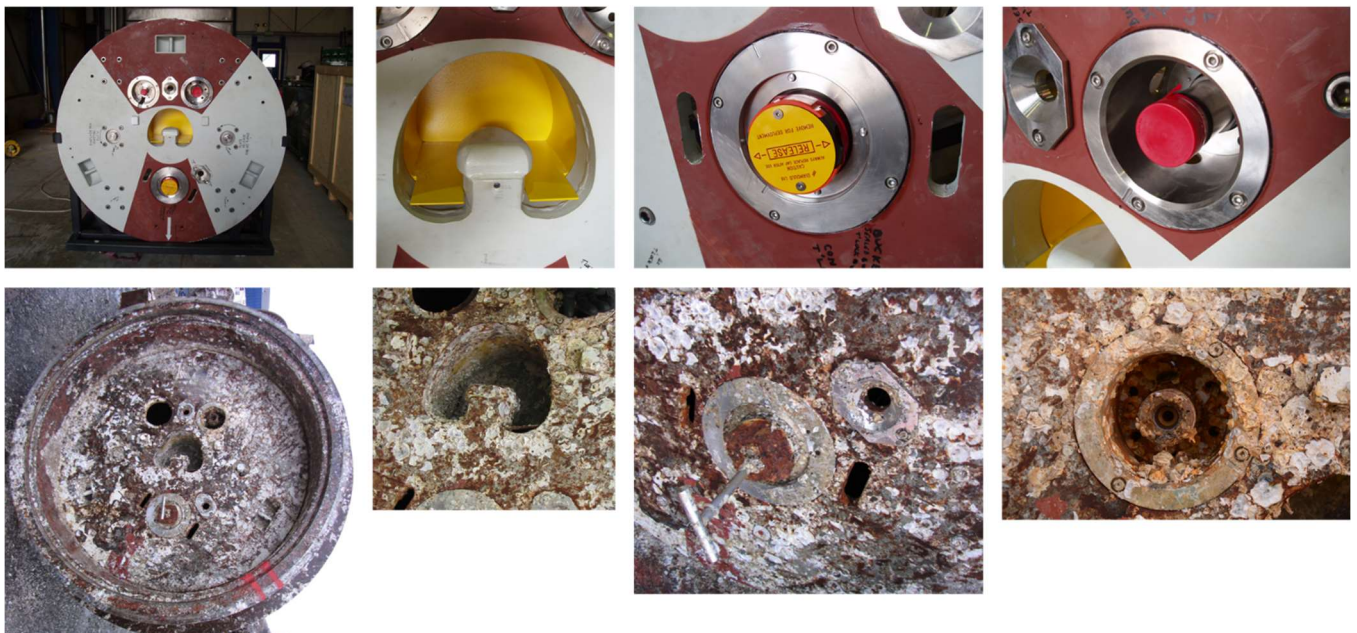
A photographic comparison of the cartridge plate is seen in Figure 29. Clearly there is a marked visual difference due to biofouling, but a more detailed study shows that overall the components have survived well, in particular the stainless steel 316L parts including fasteners. Most fasteners were removed easily with hand tools and did not require to be cut or drilled.

Figure 29 - Comparison of cartridge plate and connectors

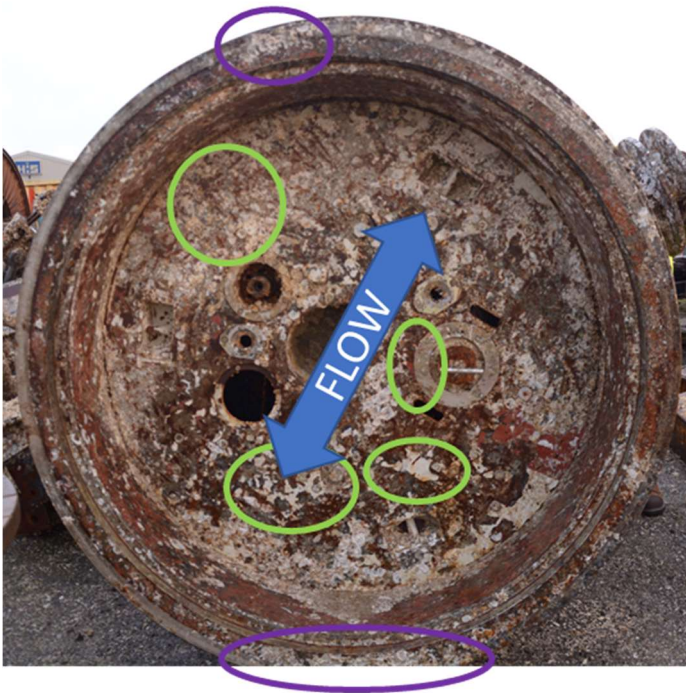
Figure 30 - Tower top with cartridge plate. Green circles indicate remaining paint, purple circles indicate thicker biofouling regions on flange

- It is notable in comparison to the tripod that the paint on the cartridge plate has almost entirely disappeared. Some of the paint may well have been removed during the scraping of the biofouling from the cartridge plate as there are indications of mechanical biofouling removal but there is significant indications of corrosion on much of the plate, indicating the paint had fallen off whilst it was still submerged. Unfortunately, it is not possible to provide a conclusion of the root cause of paint removal.

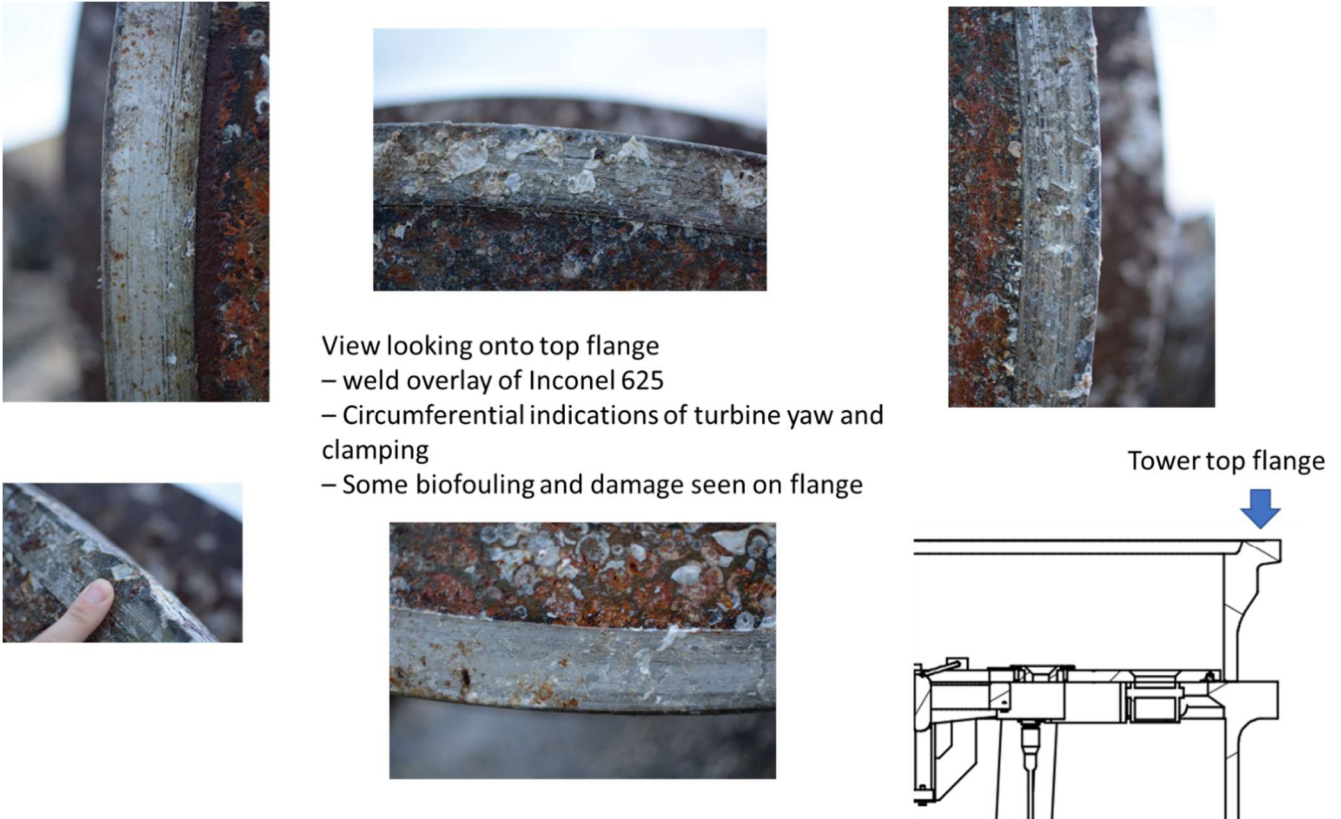
Figure 31 - View of tower top flange

Inspection of the tower top flange was completed, as this was an important feature of the TGL turbine. The yawing turbine used this flange surface as a yawing bearing surface between tides, but during generation this surface was used to create friction that enabled reaction of yawing moments into the foundation. It is a carbon steel flange with a weld overlay of Inconel 625.

- Circumferential marks are present from both machining marks and also where the turbine used this as a yawing bearing surface.
- There is no particular location that show greater wear than others
- There is indication that biofouling is more prevalent in one direction, which correlates to approx. 60 degrees from the flow direction (purple circles in Figure 30). No particular conclusion can be drawn from this relating to the flow direction and prevalence of biofouling, given the lack of evidence from the tripod structure.

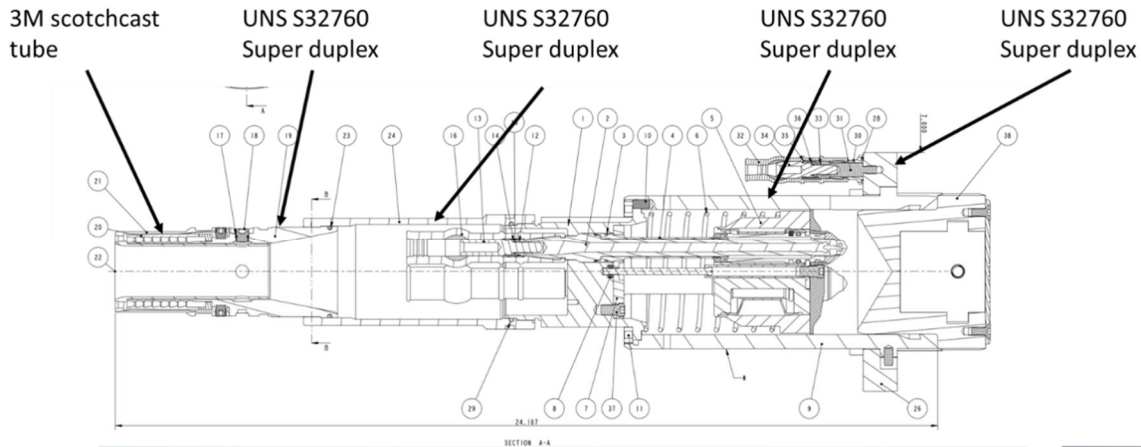
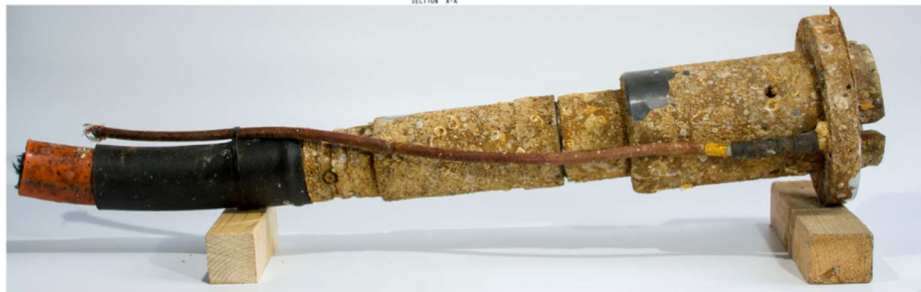
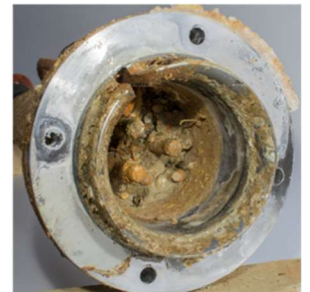
Figure 32 - Assessment of Diamould power connector

- Super duplex stainless steel has resisted corrosion well, but is not immune to biofouling.
- The synthetic compounds (3M Scotchcast and HDPE) are very resistant to biofouling
- The pins of the connector show signs of corrosion, but this connector was exposed to seawater for prolonged periods of time throughout its lifetime. The ROV cap was not properly in place, and it was clear when this was removed that there was significant biofouling inside the top of the connector. Proper and timely connector capping would have likely reduced this considerably.

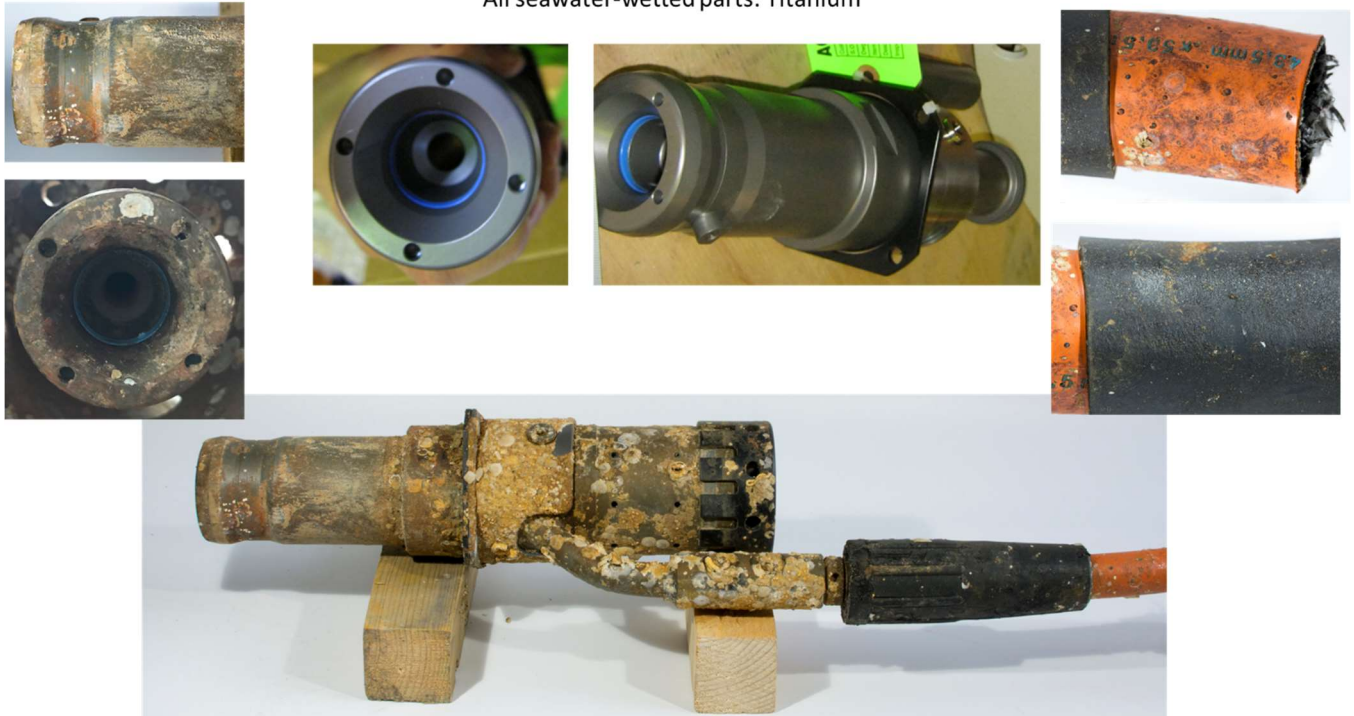
Figure 33 - assessment of Seacon fibre optic connector

- The titanium surfaces are not immune to biofouling, but once scraped off it is apparent that the titanium surface is undamaged
- There is no apparent corrosion on the titanium surfaces
- Rubber and HDPE materials are biofouling resistant.
- One of the major concerns during build was the use of M4 bolts to clamp the connector to the flange. This was impossible to change at the time. However, it is apparent that even these small bolts have survived well and there is little evidence of corrosion, thread damage or even discolouration.
- The tip of the connector appears to have biofouling on it – this is likely due to the fact that the ROV cap was not installed correctly.
- It was very difficult to remove the stainless mounting bucket through the cartridge plate as the biofouling prevented it coming through the near size for size hole.

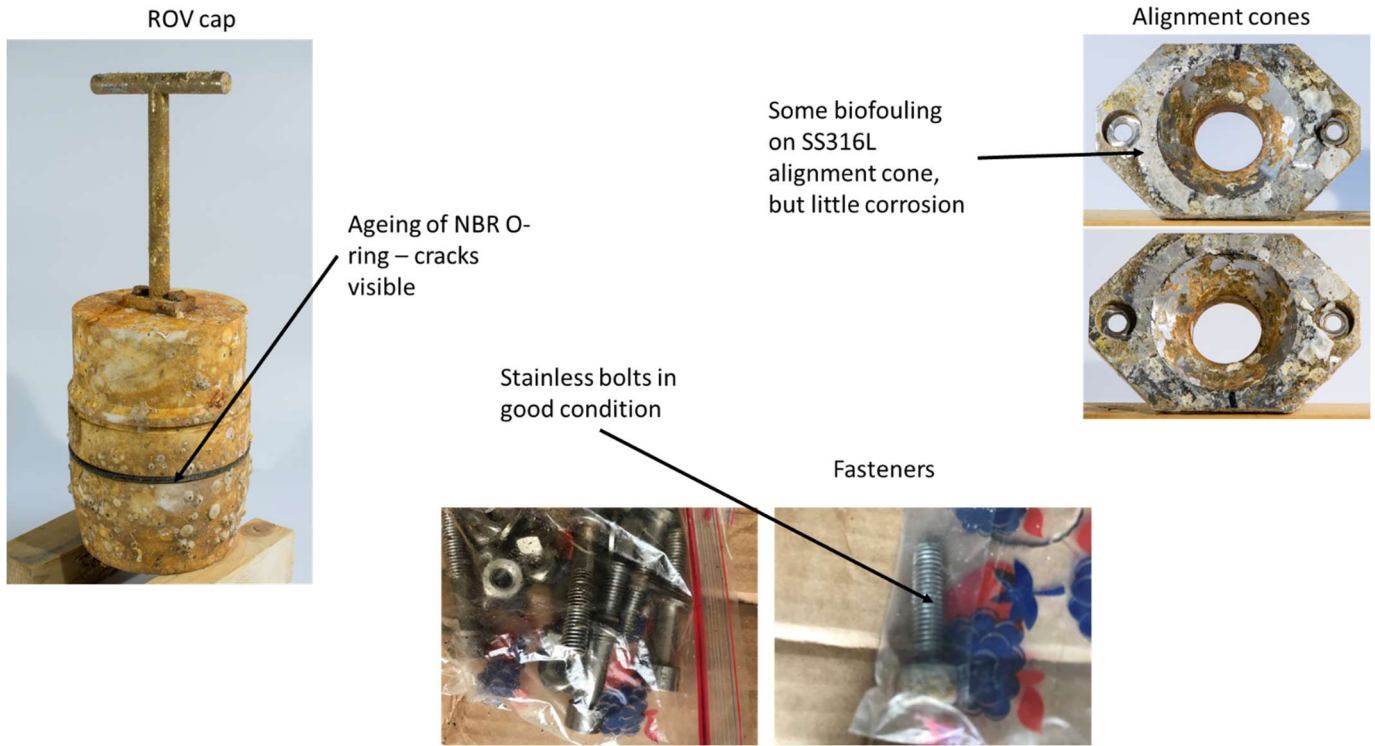
Figure 34 - Assessment of other small components on the cartridge plate

- Stainless fasteners have survived very well, even those exposed to the tidal stream on the top of the cartridge plate.
- The NBR O-ring material has shown signs of ageing and cracking. It is not clear what conditions have caused this as the history of the part is not known. UV, temperature, and long term exposure to seawater can all cause ageing effects.
- The yellow plastic connector cap has more biofouling compared to the connector hoses. Examples of mature barnacles are present.
- SS316L alignment cones have survived well, with little corrosion. Some biofouling is present, particularly on the upper surface exposed to the tidal flow.

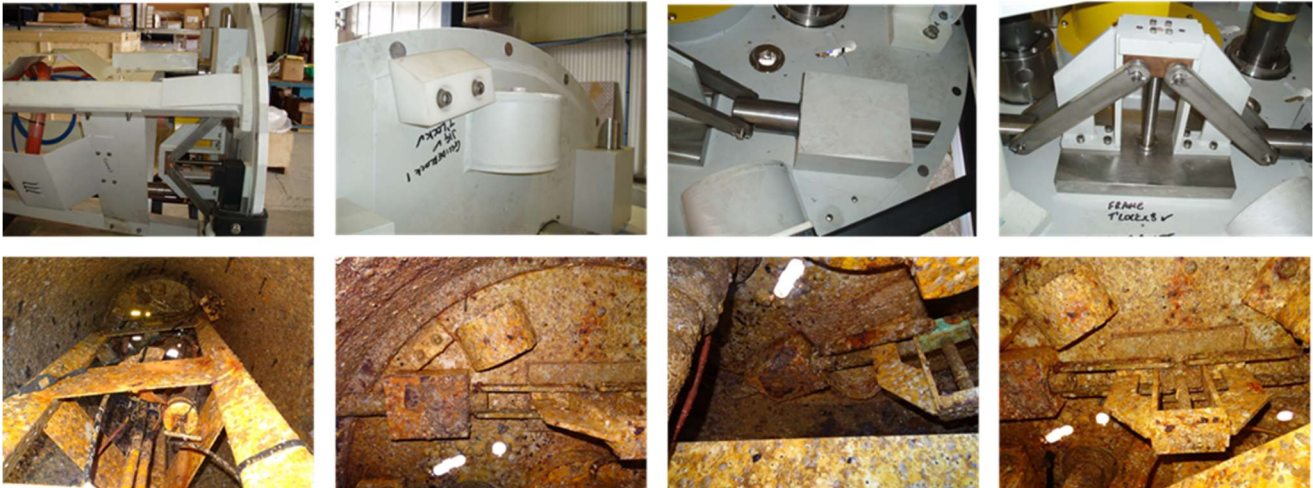
Figure 35 - Cartridge plate internal features

- Much lighter biofouling
- Paint in good condition under biofouling
- Minimal fouling on cables

- Condition of these components is generally quite good. Paint has survived well under the biofouling
- Levels of biofouling are significantly lower than seen on external surfaces.
- Cables, cable sheaths and cable ties are in excellent condition.
- It is worth noting that the ROV connector cap was found loose in this volume. This is photographed in Figure 34 where O-ring cracking can be seen. It is possible that this was lost up to 10 years ago and the O-rings have been left exposed to seawater for the entire deployment time, hence the ageing and cracking.
