# FoDTEC final summary report

Author: Tim Warren  
Date: 07/05/2020  
Reference: FT-008  
Version: A

After the removal of the TGL tidal turbine foundation that was installed at EMEC's Fall of Warness tidal test site, the FoDTEC project has completed activities to assess biofouling, corrosion, metallurgical defects and electrical connector longevity. Work has been completed by the following partners in the project:

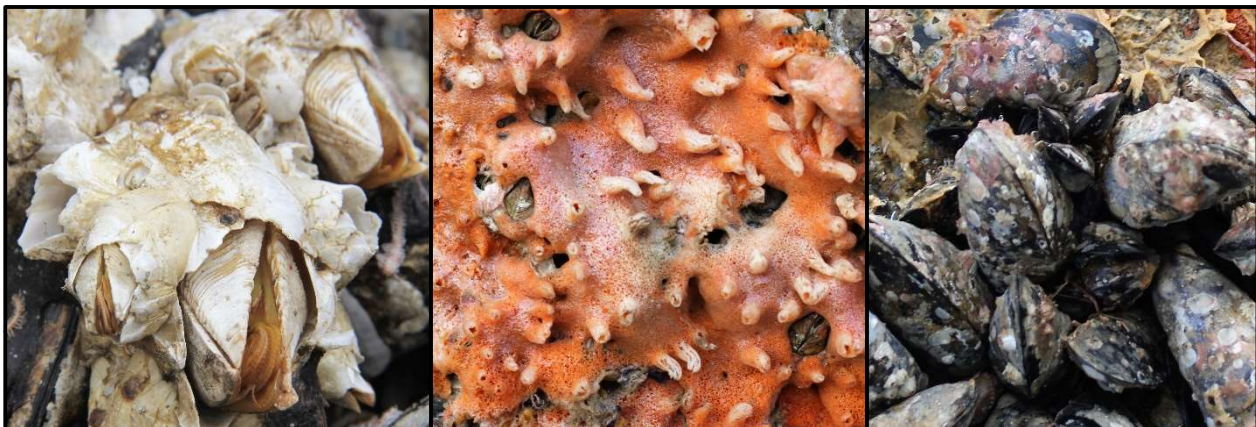
Tower top survey: this structure was almost entirely covered in biofouling organisms creating a complex matrix extending typically 8-10cm but in places to over 12 cm in thickness (Figure 5). The dominant species were *Chirona hameri*, *Mytilus edulis*, and a wide variety of sponges, especially underneath features. Significant fouling was observed of saddle oysters, a turf of hydroids, and the barnacle *Balanus balanus*. Biofouling of structures placed in the marine environment will undergo a series of successional changes, depending upon the season of deployment. Pioneering macrofouling is often associated with colonial hydroids. After prolonged deployment, larger and more slow-growth species may dominate fouling. Studies of the fouling assemblages on the TGL tripod reported here can be considered as indicative of 'end-stage' or 'climax' biofouling communities on steel in these habitats. Once these stages have been reached, the assemblages observed here would not be expected to change much over time, except for localised areas of disturbance. Reports from the oil and gas sector have identified similar fouling assemblages on long-term deployed infrastructure in the North Sea (Forteath *et al.*, 1982). Patches of thicker fouling versus exposed substrate indicate that some level of disturbance can and does occur, perhaps as the consequence of large sediment impact.

Figure 5 - The vertical subunit of the tripod surveyed on 15 September 2019. Note the thick encrustation of barnacles and mussels

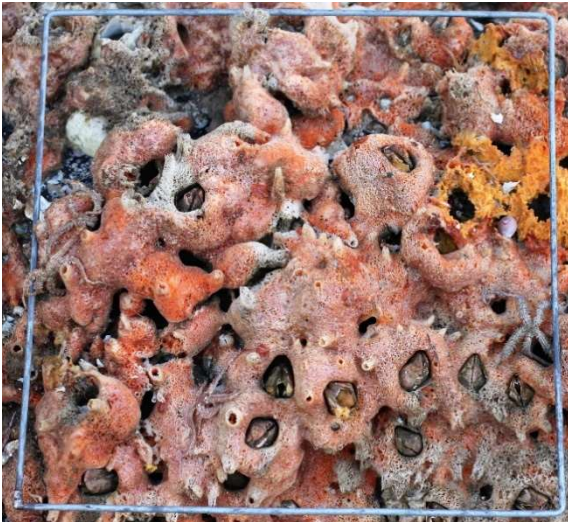
Figure 6 Images of quadrats (25 x 25 cm) were collected from the recovered tripod.

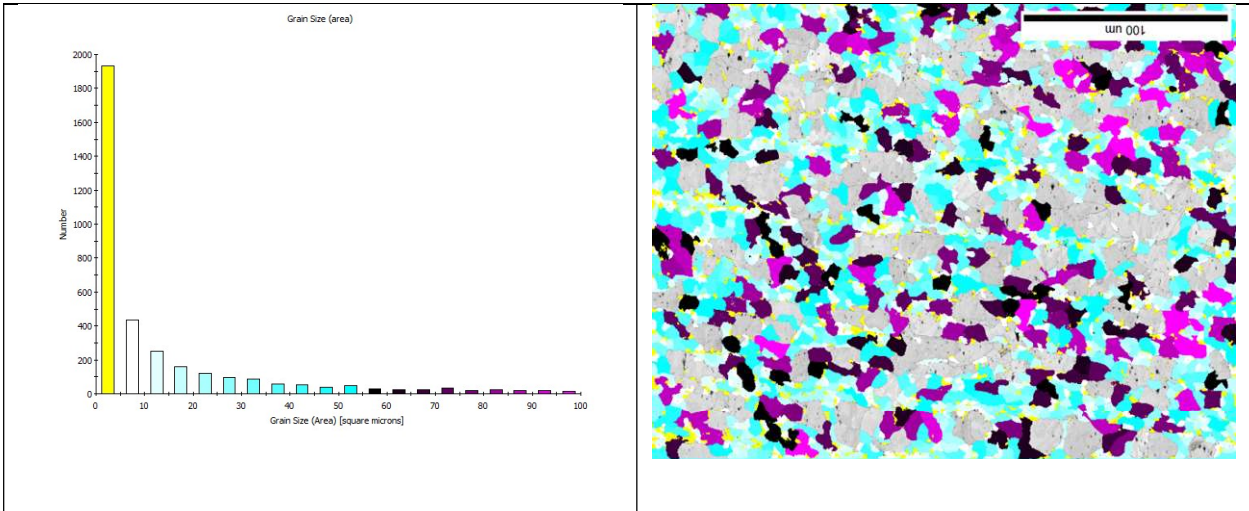
Figure 13 grain size chart indicating the smallest grains and then the range 10 to 50 and 50 to 100 in colour coded system represented in Figure 14

Figure 14 Image Quality map with colour coded grains depending on the size as per diagram Figure 13. Smallest grains in yellow are linked to perlites and show the banding phenomenon, larger grains are of ferritic nature

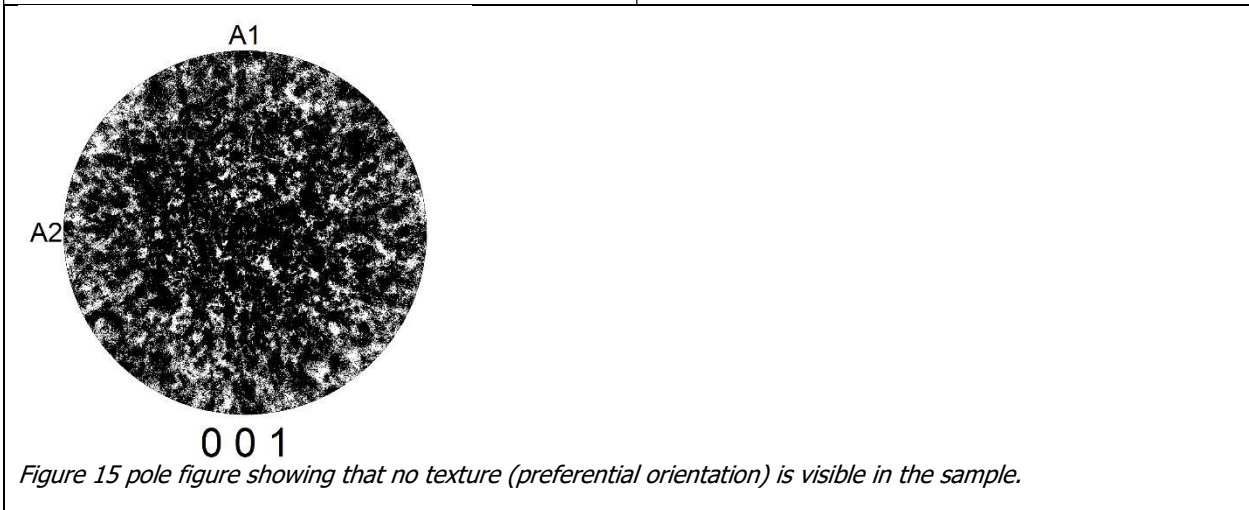
Figure 15 pole figure showing that no texture (preferential orientation) is visible in the sample.

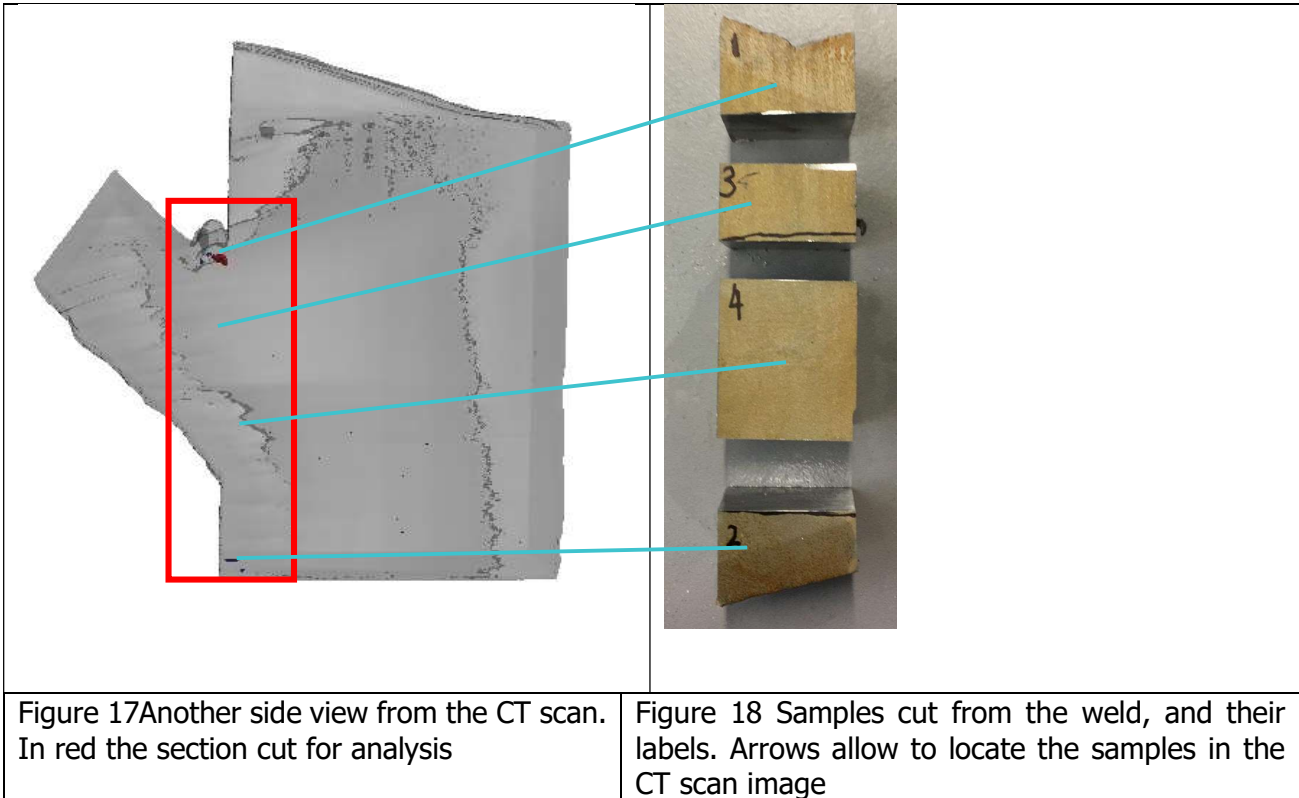
Figure 18 Samples cut from the weld, and their labels. Arrows allow to locate the samples in the CT scan image

Area 1 (Figure 18) The optical microscopy observation shows a variation in the texture of the sample (elongated grains above the red line in Figure 19, Widmannstatten microstructure between the red and the green line and equiaxed grains below the green line). On the top elongated grains are visible, then a Widmannstatten microstructure can be observed with an area containing equiaxed grains beneath. Closer observation using electron microscopy on the top section (Figure 20, Figure 22 and Figure 24) indicated that the grain start recrystallising as elongated dendrites growing perpendicular to the top surface and are then quenched during the welding, and rapidly cooled provoking a large outer grain while on the inside very small single grains were formed (Figure 21). The specific orientation relationship between the finer grains in this top section is 47 degrees, which corresponds to the orientation relationship in the bottom section of this sample (below the red line) typical of body centre cubic ferritic iron under rapid conditions transforming the ferritic structure into a Widmannstatten one, generally present in welds and seams. This microstructure consists of intertwined lamellar grains, with a relationship similar to the one showed for twinings, deriving from the fast cooling of austenitic grains produced in the ferritic steel by heating above the stability temperature of ferrite (which happens during welding) . Porosity is also visible in this area indicating (1) a decrease in volume of the material, which corresponds with the description of the twinning formation creating the Widmannstatten microstructure, as described by Cox (1954), (2) gas formation during the welding process. An evaluation of the strains in these areas was performed (Figure 23, Figure 24). The Kernel maps are shown in red the areas with higher strains. Analysing the results it can be noted that areas of major strains are the "shells" of the elongated grains in the welding areas (Figure 24), containing the finer grains deriving from the quenching process after welding. In detail (Figure 23) further strain is visible in the Widmannstatten area just below the elongated dendrites (below the red line in Figure 19, Figure 20, Figure 22) , while the strain decreases in the Widmannstatten area further below. This location of the strain and the associated location of the

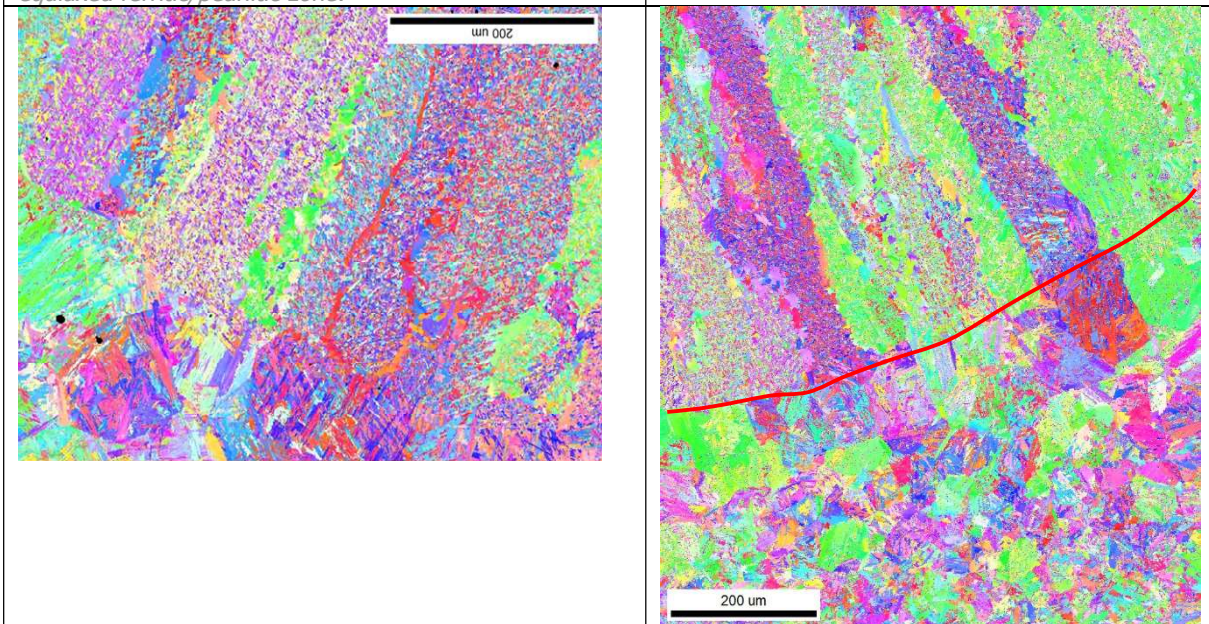
Figure 21 detailed view of the boundary between elongated grains and Widmannstatten area. It is visible here that the elongated grains are formed by minuscule

Figure 22 Corresponding IPF map of area in Figure 20 showing the orientation of the grains and the

| <p><i>grains with specific orientation and correlated to the orientation of the twinned grains below</i></p> | <p><i>relationship between the orientations (analysis courtesy of Rene de Kloe – EDAX/Ametek)</i></p> |

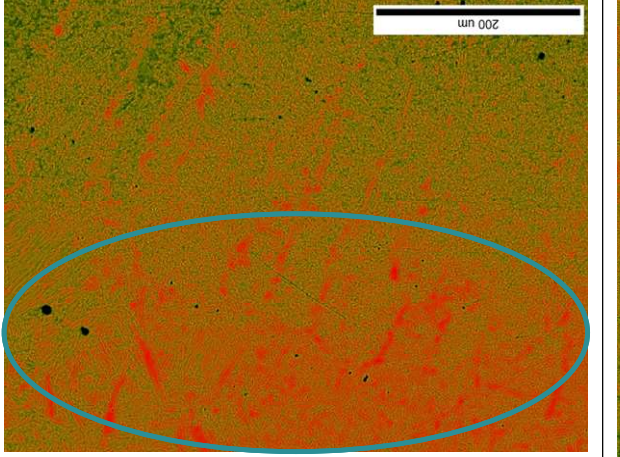
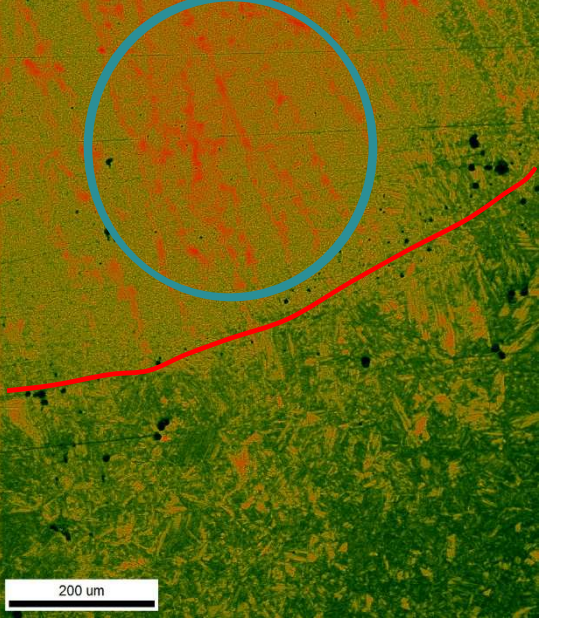
| <p><i>Figure 23 Kernel average map of Figure 22 showing the maximum strain along the edges of the elongated grains at the boundary Widmannstatten zone and on the upper layer of the twinned zone (circled in blue)</i></p> | <p><i>Figure 24 Kernel average map of Figure 20 showing the maximum strains at the boundary of the elongated grains (circled in blue). Visible porosity along the line limiting elongated and the Widmannstatten area. (analysis courtesy of Rene de Kloe – EDAX/Ametek)</i></p> |

The sample A3-1 shows a microstructure with evidence of overheating, as expected in a welding area, with a fine grained quenched top layer and a Widmannstatten area just below. The presence of porosity and the fact that the Widmannstatten microstructure is harder and more brittle, could have caused failure in the material and high strain concentration. However, fact that the porosity is not deformed seem to indicate that the microstructure is convincingly the result of the welding process more than the response of the stresses during use, and no fractures or fatigue corrosions were initiated in this areas.

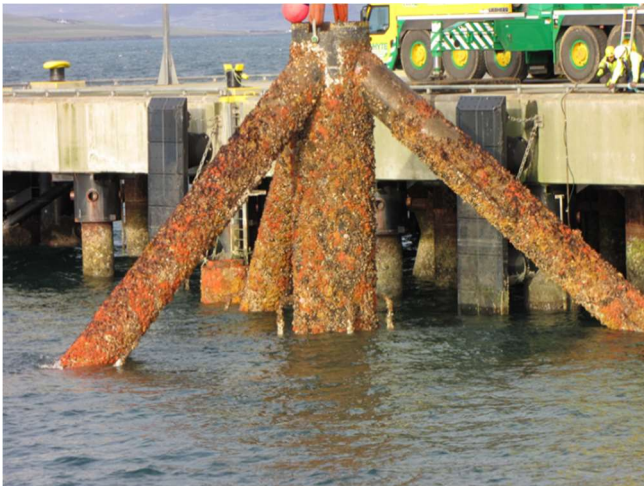
To remove the tripod, it was necessary to remove some of the structural members due to the mobile crane lifting capacity. As a result, the top section main tube was cut off whilst the tripod was in the sheltered location. In addition, the main part of the central vertical tube was cut away, as well as some of the horizontal stiffening members were removed.

Lift 1 too heavy

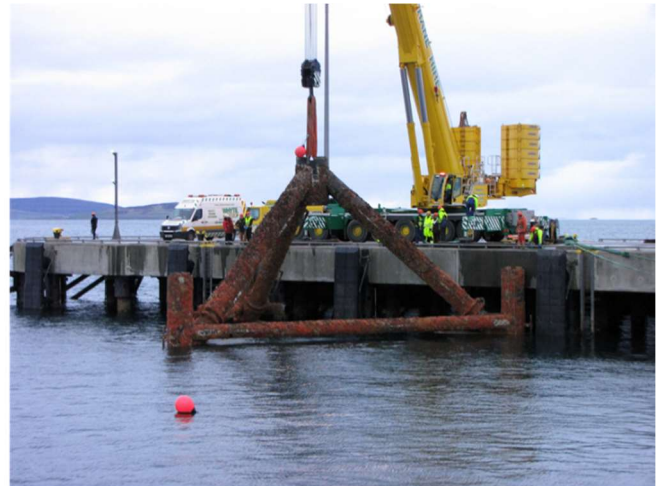
Lift 2 with central vertical member and lower horizontal members removed

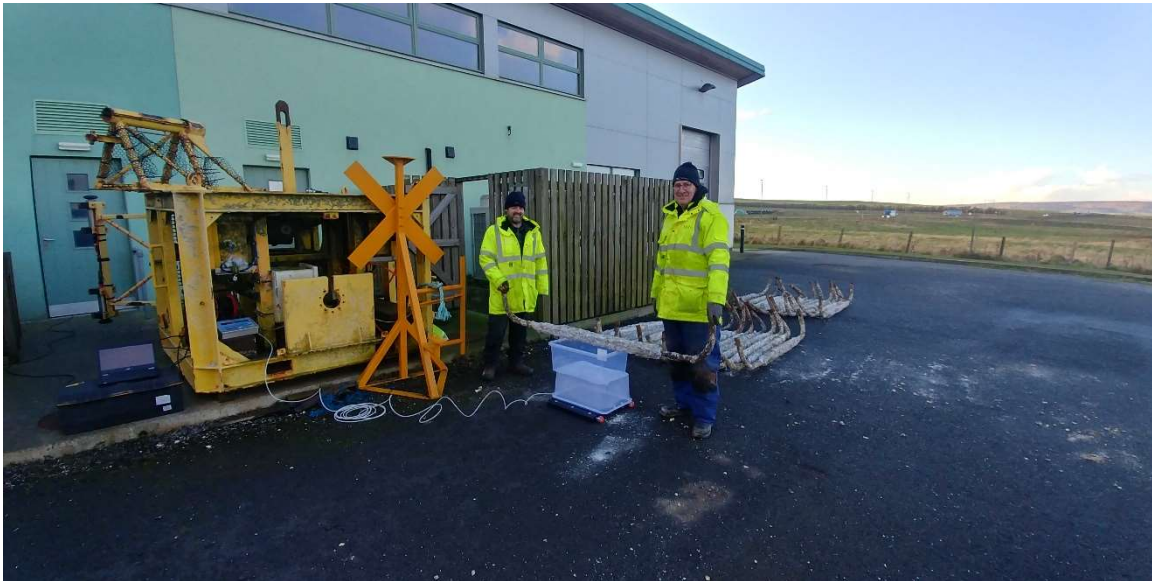
21kg, with a range of 17-26kg. The original mass was not defined on the top-level drawing, but from other data it is assumed that each anode was 50kg when it was originally attached.

It is perhaps surprising that any anodes remain after such a long time, but 29 anodes each of 50kg provides a large total of cathodic material to provide protection and is perhaps the main reason why the tripod and paint remains in relatively good condition.

Figure 27 - measuring the mass of anodes by EMEC staff
